Lake Nyos Dam Assessment

Cameroon, September 2005

Joint UNEP/OCHA Environment Unit

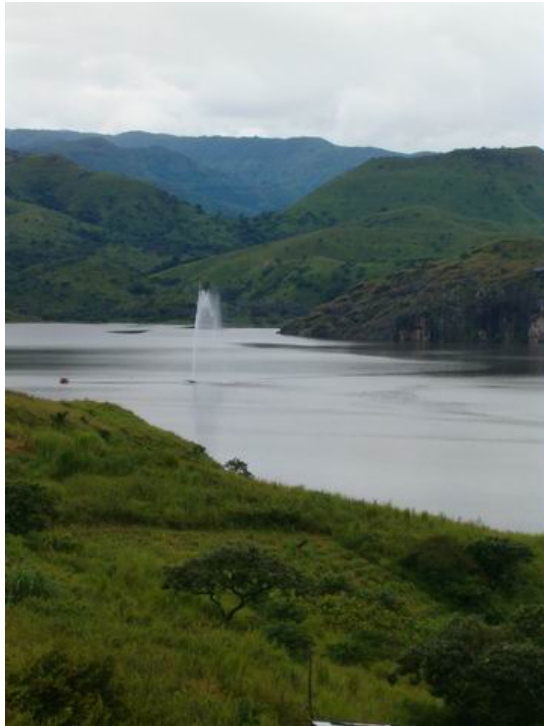
Degassing project

The current degassing project constitutes of a big pipe placed vertically into the lake. The water in the pipe has been initiated to flow vertically and has been kept flowing up since. As the water pressure drops, while the water flows up, the gas evaporates in the pipe causing the density to drop dramatically. Thus, the water is pushed upward by hydrostatic pressure and leaves the pipe at the top with high speed, causing a fountain up to some 50 meters high.

This project is effective and generates a lot of information from its monitoring and study program. The current degassing project is estimated to release some 20,000

tons per year, while 5,000 tons per year are emitted into the lake by the volcano mantle. To degas the entire lake, approximately 600,000 tons of carbon dioxide will have to be removed. It is estimated that this will take 30 years⁴

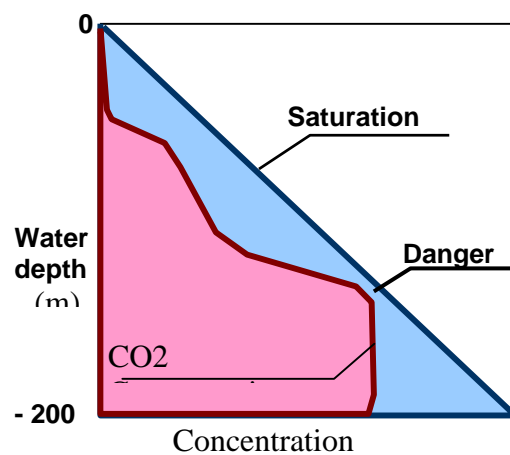
The lake is situated within an old volcanic crater. This volcano releases carbon dioxide into the water at the bottom of the lake. The gas dissolves in the water, increasing the water density. The solubility of gas in water depends on the water pressure. This physical phenomenon is known as Henry's law. The figure on the right shows that water can contain more gas at greater depth. In other words, the saturation increases with the depth. The figure also

schematically shows the actual concentration of carbon dioxide in the lake. Where this concentration becomes higher than the saturation level, the gas can no longer be dissolved and small gas bubbles will appear. The gas bubbles in the water will reduce the water density. When this happens at the bottom of the lake, the relevant water volume will become lighter than the volumes above it. The water volume with the gas bubbles will rise (float) to the surface. Upon reaching the surface, the gas will be released into the air and a disaster similar to the one in 1986 can occur.

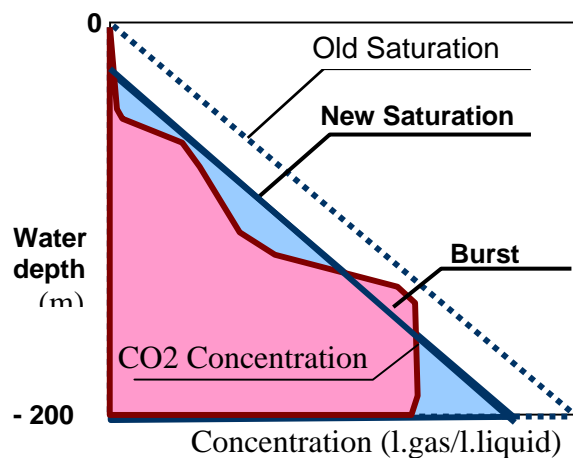
Reducing the water pressure at a fast pace

Lowering the water pressure reduces the solubility. When there is more gas in the water than can be dissolved (the solubility), the water gets over saturated. When that happens in a short period of time, the gas comes free, creating small gas bubbles. The gas bubbles decrease the density, so the relevant water-gas volume will rise. The same happens when you open up a bottle of (carbonised) soda water. This is how a fast reduction of the water level can cause a gas burst.

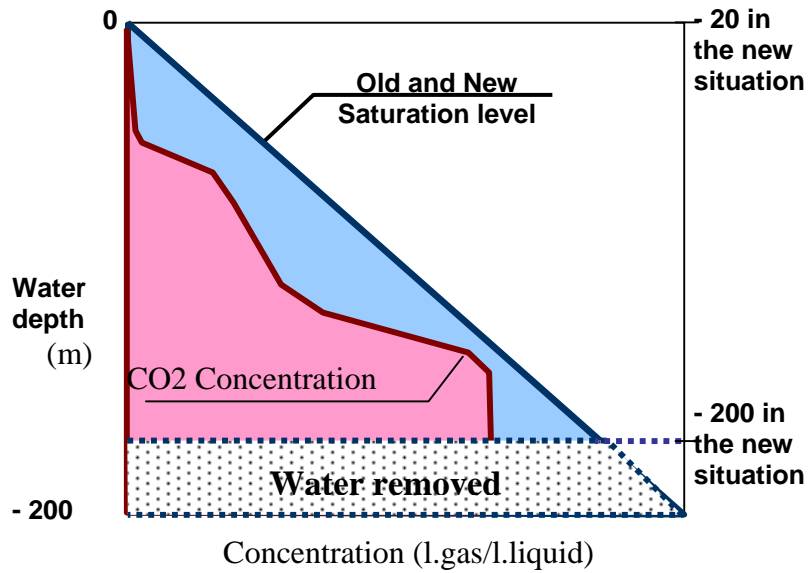
However, if water is removed from the bottom of the lake, something different will happen. As is shown in the third figure below, this will just take out some water with a high percentage of gas content being dissolved in it. A problem will only occur if this is done too fast, as the water level goes down, while the high density water layers have no time to adjust. Experience from the degassing project will be most useful to estimate the speed of the self-equalizing effect of these water layers.
